**Douglas James 'Doug' Shymanski  
Cyclone Drilling, Inc.  
307818575/S06705**

**Date and Time of Accident:** December 12, 2005, approximately 3:00 pm.

**Accident Site:** Rig 18, Warbonnet Well 9B-10D in the North Jonah Field, outside Big Piney, WY (N 42°34'756" W 109°42'039")

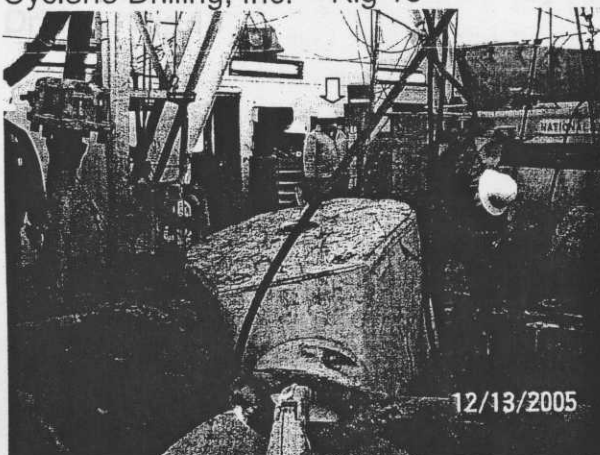
Examining the dropped blocks on the rig floor. Dean Cook is standing with his back to the heater, facing the weight indicator at the driller's console.

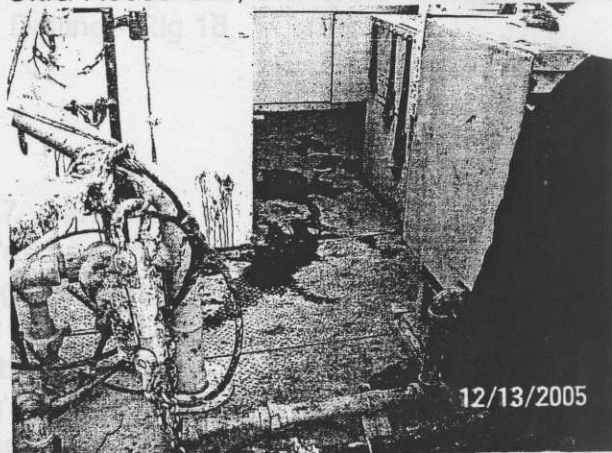
The piping to the heater created a trip hazard between the driller's console and the doghouse.

- All employees should be briefed on the facts and circumstances of this fatal accident
- Cyclone Drilling needs to implement a program of inspecting the crown and sheaves in accordance with the API guidelines
- Cyclone needs to implement a means of training personnel responsible for sheave inspections as to what to look for
- Cyclone needs to develop and implement a program of when to take a sheave out-of-service when it is worn and prior to fatigue leading to a catastrophic event
- Cyclone needs to develop and implement procedures to ensure that information on rig accidents, near misses, and equipment failures is shared with company personnel as necessary to ensure appropriate preventative action is taken
- Equipment (i.e. heater piping) should not be positioned where it restricts a route of exit in case of emergency

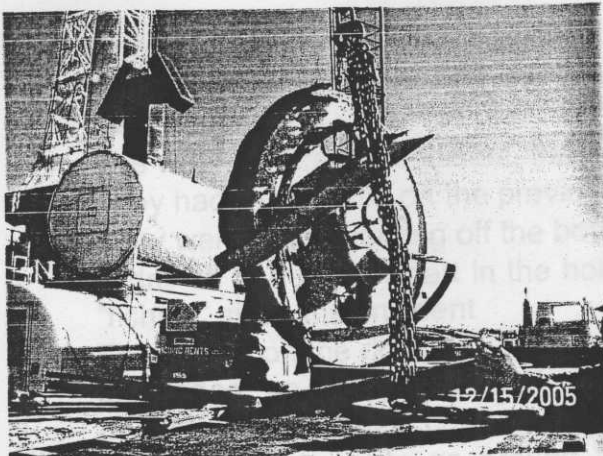
The failed fast line sheave from Cyclone Drilling - Rig 18

Coon notes that, "basically, the cable entered the sheave off center and slid down the failed flange as the flange positioned the cable in the root. Over time the action of the cable sliding down the failed flange reduced the flange thickness due to wear. The result of the cyclic force during sheave rotation was fatigue cracking of the failed flange. Failure of the sheave occurred when a fatigue crack became critical and propagated through the thickness of the flange. ***The preliminary engineering analysis suggests that monitoring the thickness of the flange to remove the flange from service prior to the onset of fatigue would be the safest approach***" (emphasis added).

According to the engineering analysis performed on the fast line sheave removed from Cyclone Drilling Rig 18 following the fatal accident, the sheave was beyond worn; it was extremely fatigued. In the summary of the preliminary engineering analysis, Dr. Coon says, "It is very important to understand that once wear has resulted in a thickness reduction of more than 20% of the original flange thickness, the fatigue reliability of the sheave is questionable".

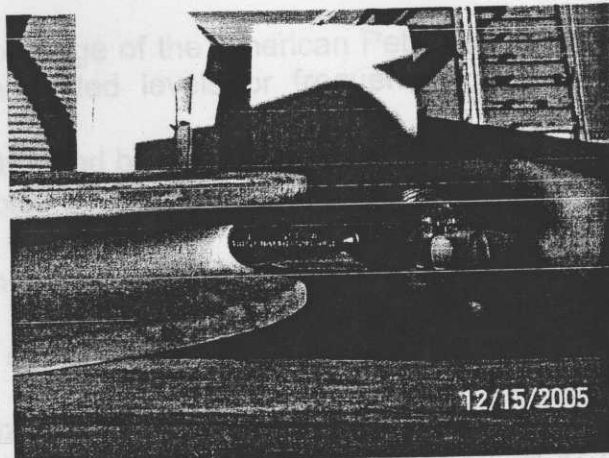
New fast line sheave to be installed on Cyclone Drilling Rig 18

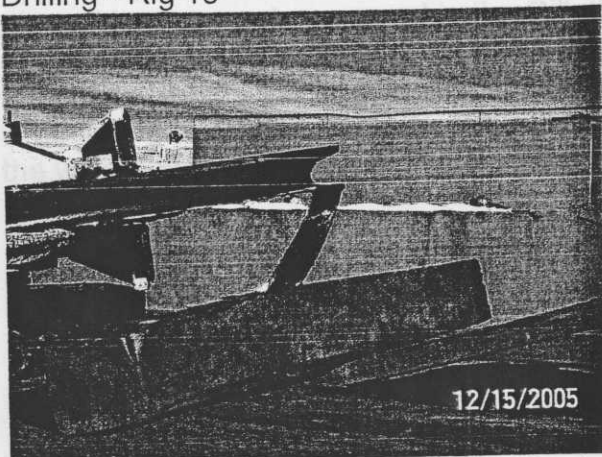
The failed fast line sheave from Cyclone Drilling - Rig 18

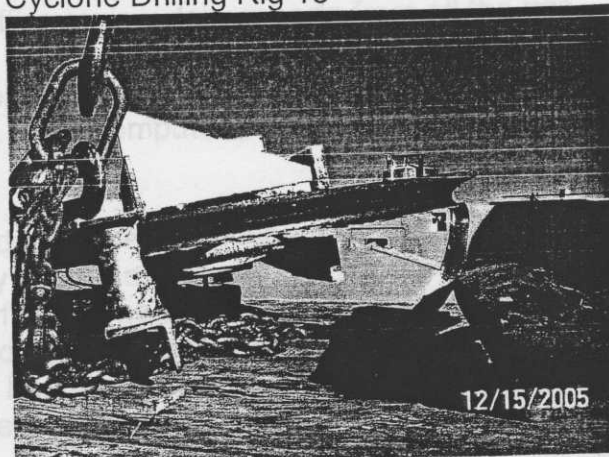
The failed fast line sheave from Cyclone Drilling - Rig 18
